## Hadrian House, Newcastle upon Tyne

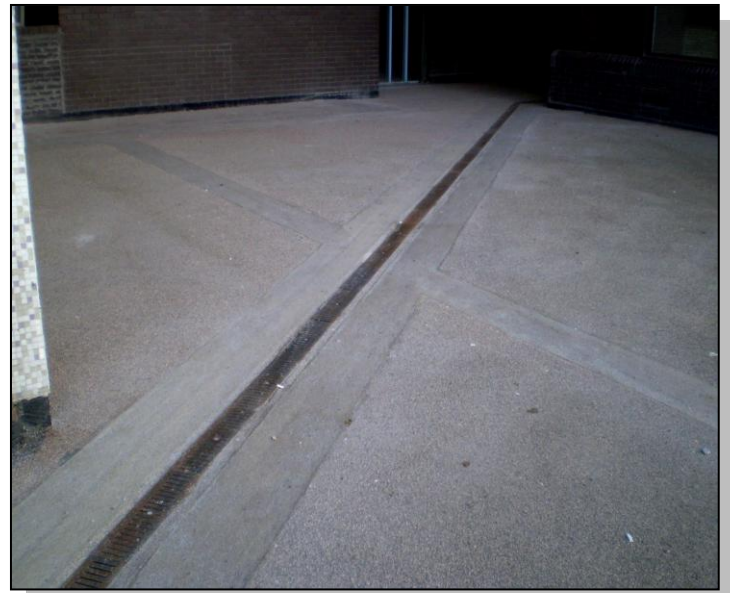
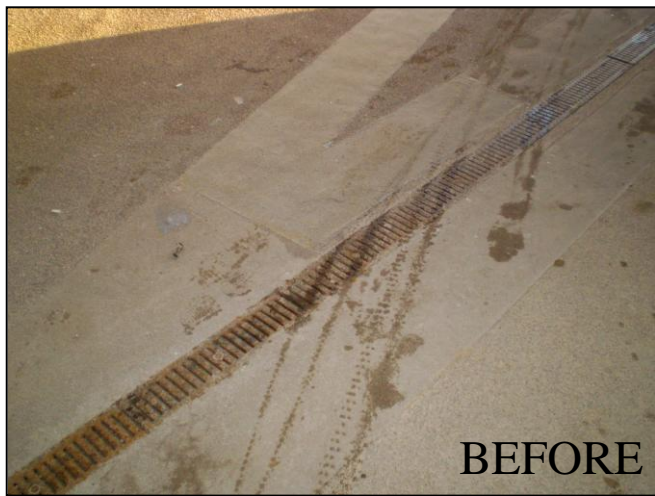
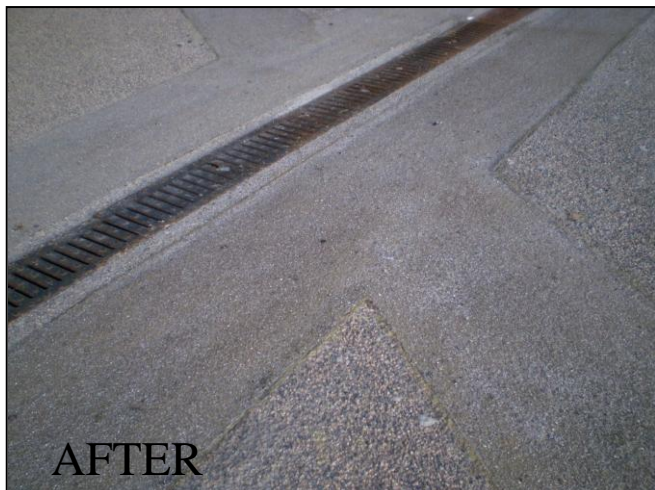
After several attempts to stop water ingress through the roof of the offices using alternative systems, the contractor asked Xypex to specify and supply a permanent solution.

The roof, which is also a busy walkway between two areas of the city of Newcastle, has over 300 linear metres of movement joints and it was these that had failed. The specification called for the removal of the existing movement joint, then the application of a bespoke, project specific, Xypex joint repair. Xypex Concentrate Dry-Pac and a Xypex Concentrate slurry coat were utilised before Xypex FCM was applied as a final coat to facilitate some movement at the joints without the risk of further water ingress.
